Recovering lost belt press performance

U.S. refinery saves on capital investment with a belt press rebuild

Case story

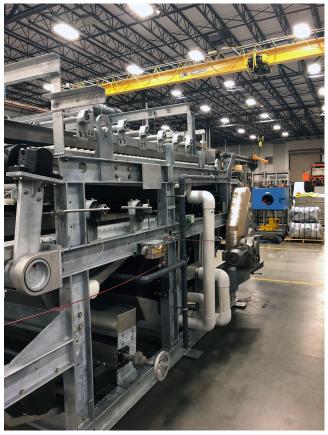
An example of an Alfa Laval AS-H belt filter press after refurbishment (Alfa Laval service center photo)

Arriving on site, the certified Alfa Laval field service technician carefully reviewed the prepared list of itemized repairs and adjustments. Working closely with plant personnel, each item was addressed with parts being replaced as needed. Some of the repairs included multiple rollers and bearing replacements, along with replacement of all the support wear strips under the filter belts, rubber seals, hydraulic motor, tensioning and steering cylinders, steering/tracking valves and paddles, and much more. All of this had to be tracked and tuned in. Training was also performed with the operators, highlighting what key things to look for in the process that would identify that adjustments should be made. This type of training is part of what Alfa Laval feels is critical in building the trust and relationships with customers. Sharing knowledge and building the ability for the customer to be self-sufficient will help ensure that the customer is able to achieve the best results with their equipment, leading to a long relationship built on trust.
